Waters Edge Community Development District

Board of Supervisors' Meeting June 23, 2022

Waters Edge Roadway Drainage Inlet Review

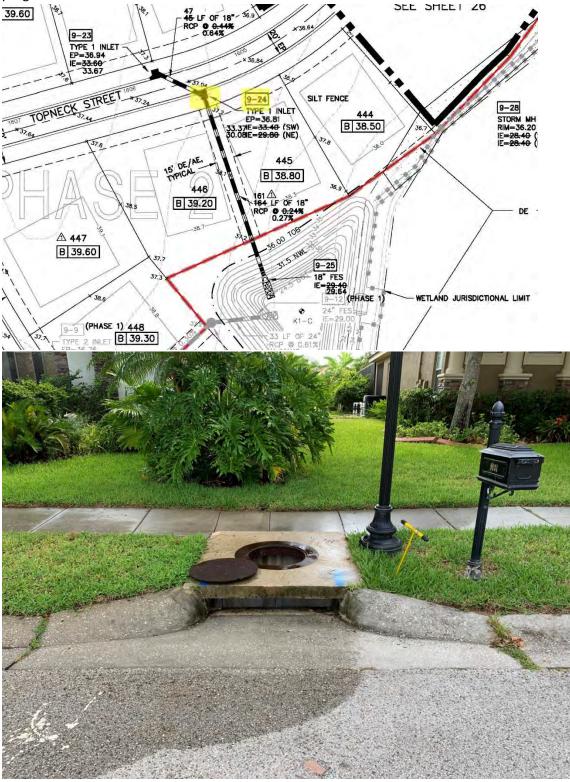
INLET 9-24

Slight depression observed in turf adjacent to southwest corner of Inlet 9-24. Internal review shows possible previous repairs. No structural deficiencies noted. Recommend periodic inspection for progressive deterioriation of area.
