Waters Edge Community Development District

Board of Supervisors' Meeting June 23, 2022

Waters Edge Roadway Drainage Inlet Review

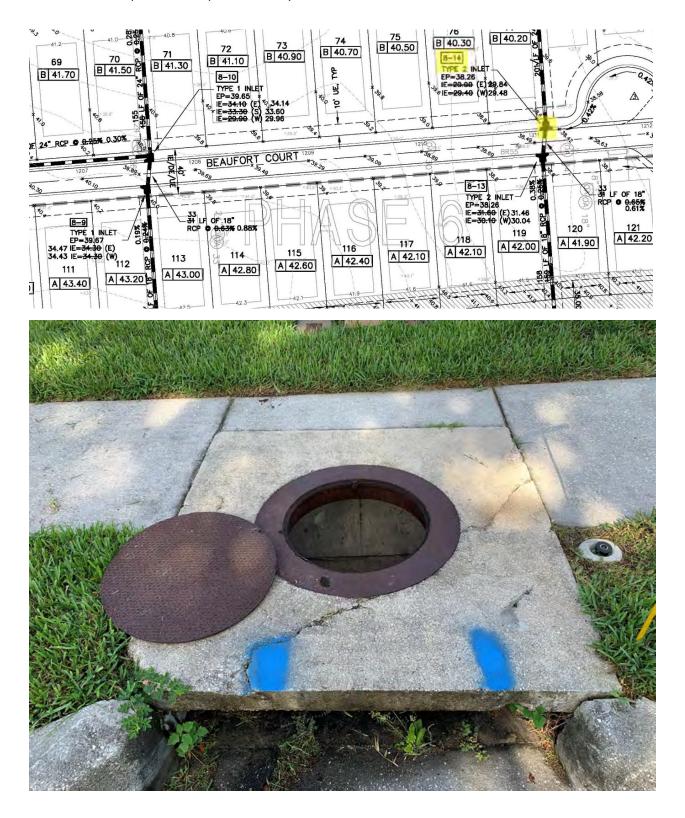
INLET 8-14

Inlet top cracked. No internal deficiencies observed. Recommend periodic inspection for progressive deterioration. Replace inlet top as necessary.
